March 15, 2002

Washington State Legislative Building Rehabilitation Project

Results of “Push Test”:

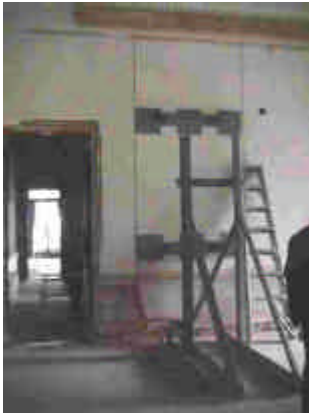
I wanted to update folks on the results of the “push-test” that took place in the Auditor’s office on February 28th. A section of wall was repaired and modified to represent a typical wall in the Legislative Building. Our goal was to determine how much force the walls would take before they would fail. The Legislative Building Rehabilitation Project is involved in developing a seismic upgrade plan that would assure maximum safety to the building occupants as they exit the building during an “event”. Since many of the exit routes travel next to “hollow-clay” tile walls, we needed to see if they required additional structural support. The “push-test” was designed to exert a steady pressure against the wall and then use scientific instruments to measure movement. Textbook calculations of forces exerted against a hollow-clay tile wall would indicate that the wall should have failed at 600 lbs. of force against the wall section. That failure would have result in cracking of the tile, or possible collapse of the wall. I’m attaching a picture of the test frame that was used in the “push test”.

Three prior major earthquakes have produced cracks in these walls, but they have not failed. The wall structures have remained attached at the top and bottom and have not collapsed. The architects and contractor on our project suspect that the construction methods used in building these walls have produced a superior wall. The partition walls have 1" of plaster on each side and most of the walls also have a wainscot that may provide additional support. It is important to note that cracks in walls are not dangerous as long as the wall remains standing. The cracks help to relieve the energy that travels in an earthquake and then runs into a building. Our building has done a great job of withstanding those energies and providing safe exiting routes.

Current city code requires that the wall withstand a total lateral force of 1,600 lbs. - a force equal to 60% of the weight of the wall. Old hollow clay-tile walls often require some form of reinforcement to withstand that level of pressure. This reinforcement is called "strong-backing" and can be accomplished in many ways - all of them expensive.

The test on the hollow-clay tile wall in the Auditor's office was witnessed by project team members, Building Officials from the City of Olympia, FEMA, SHPO, TVW and staff from the Auditors office. The testing process was a lengthy one that required small increases in pressure with periods of waiting to see if the wall settled into a failure. The wall withstood a pressure of 1,600 lbs. - the pressure computed to meet the city code. The project team then made the decision to continue the test to establish a level of "margin of safety". The test continued to 2,000 lbs. - a force equal to 75% of the weight of the wall - and still did not fail! It must be noted that the wall did flex (in a bow shape), but did not crack. Nor did it break away from the ceiling or floor. We are still awaiting the written test results based on the measurements taken during the test. But preliminary evidence would suggest that the skilled trades people built a great building for us 75 years ago.
